CHARACTERIZATION OF ION IMPLANTED AND  
LASER PROCESSED WEAR SURFACES

Final Report: Contract No. N00014-85-K-0066

Sara A. Dillich  
Department of Mechanical Engineering  
Worcester Polytechnic Institute  
Worcester, Massachusetts 01609

April, 1986

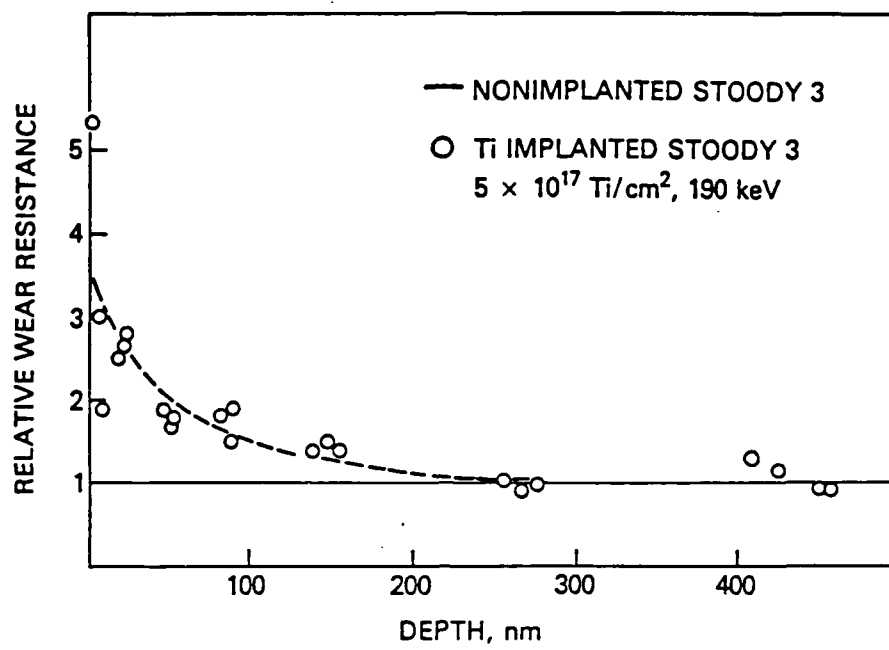
Figure 1a. Relative wear resistance of titanium implanted Stoddy 3, abraded with 1-5 micron diamond, vs. depth (Ref. 9).

and titanium implanted samples, relative to that of the nonimplanted alloy can be seen in Fig. 1. Ti implantation ( $5 \times 10^{17}$  Ti/cm<sup>2</sup>, 190 keV) of the alloy created abrasion resistant surfaces (Fig. 1a) which also exhibited a 50 - 70% reduction in dry sliding friction (7-9). Scanning Auger microscope analysis revealed that a vacuumcarburized titanium layer was produced on the alloy in both matrix and carbide phases during implantation (7). Similar vacuum-carburized (Fe-Ti-C) surfaces found on Ti implanted steels were shown to be amorphous (10-11). However, the existence of disordered phases in Ti implanted Stoddy 3 surfaces, and the specific role of the carburized layers in the establishment of a low friction and wear characteristic in the alloy, remained to be determined.

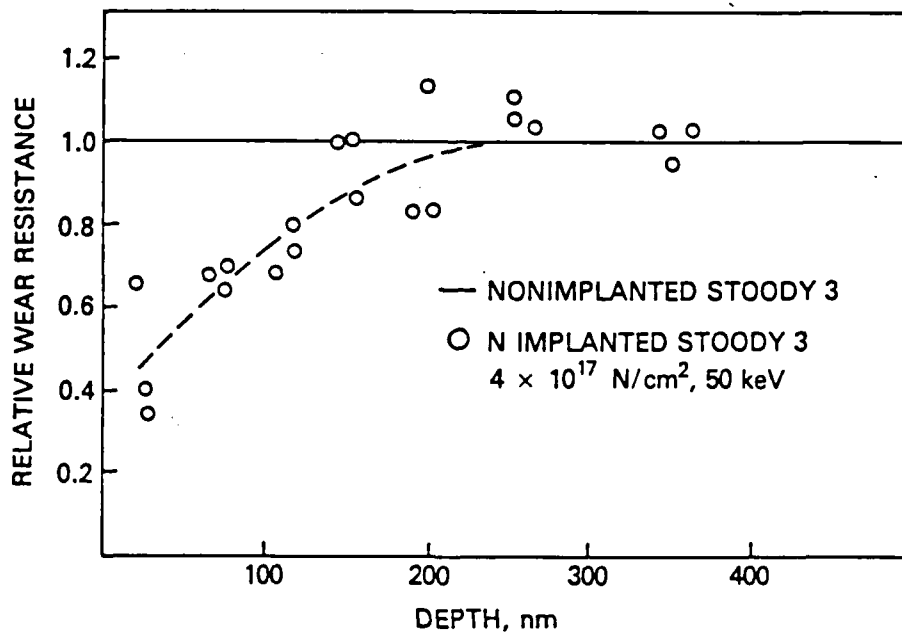
Figure 1b. Relative wear resistance of nitrogen implanted Stoddy 3, abraded with 1-5 micron diamond, vs. depth (Ref. 9).

In contrast, the abrasive wear resistance of the Stoddy 3 alloy dropped to about 1/2 the bulk value after nitrogen implantation ( $4 \times 10^{17}$  N/cm<sup>2</sup>, 50 keV). Changes in the wear mode during dry sliding were also observed after implantation, although the friction remained high (9). Nitrogen stabilization of the metastable fcc matrix phase, with a resultant decrease in surface workhardening during sliding and abrasion, was offered as a possible, but unproven, explanation of the observed behavior (9). Since nitrogen has little or no solid solubility in cobalt, its effects as a phase stabilizer have not been documented. However, nitrogen stabilization of the fcc phase in the binder alloy of a N implanted Co-cemented tungsten carbide has been reported (12).

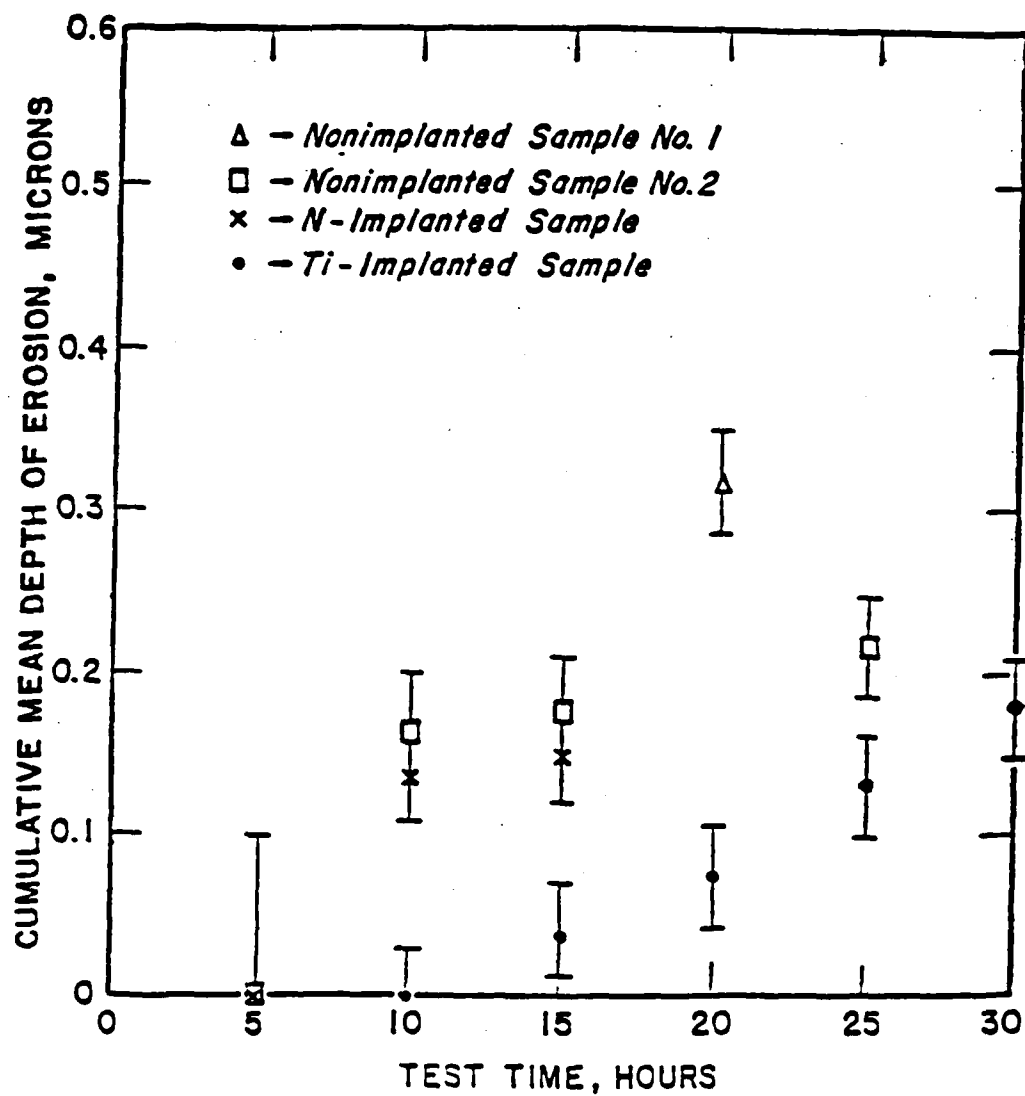
Figure 2. Mean depth of erosion vs. test time for nonimplanted and ion implanted Stoodly 3 samples.

rates of weight loss of the two nonimplanted samples (#1 & #2) shown in Fig. 2 suggests that the rate of mass loss varies with the length of the exposure interval. The incubation period (test time before weight loss is observed) was 10 hours for the nonimplanted sample (#2); however, damage to the surface could be observed after the first hour of testing. SEM inspection of the eroded surface indicated that erosion initiated by crack propagation through the carbides and by debonding at the carbide-matrix interfaces (Fig. 3). After 25 hours of testing, considerable damage to the Co-rich matrix phase was also observed (Fig. 4).

Little difference in the weight loss characteristic of the alloy was detected after N implantation (Fig. 2). However, a significant change in the appearance of the eroded surface was observed during the first hours of testing. The N implanted surface suffered an "exfoliation" process by which a thin surface layer was lost from both carbide and matrix phases. The last stages of this phenomenon can be seen in Fig. 5. The debonding and carbide crack growth processes observed on the nonimplanted sample were delayed on the N implanted sample. However, these erosion mechanisms were eventually observed after about 10-15 hours of testing (Fig. 6).

Even more dramatic changes in erosion behavior were observed after Ti implantation. The cumulative depth of erosion was much lower for this sample than for the others (Fig. 2). Although crack propagation in the larger carbides was observed, debonding at the carbide-matrix interfaces was not (Fig. 7). Apparently, material loss occurred primarily at the carbide crack sites (Figs. 7&8). Only after 20 hours of testing was damage to the matrix observed, and then much less than in the nonimplanted sample (Compare Figs. 4 & 8). However, as was the case for the nonimplanted sample, surface damage progressed rapidly after the appearance of matrix phase erosion. Indeed, separate phases on the eroded surface were barely distinguishable after 35 hours of cavitation; although, surprisingly, carbide-matrix phase cohesion persisted (Fig. 9). The preliminary tests described above demonstrate that high fluence ion implantation produces significant changes in the cavitation erosion behavior of the Stoddy alloy primarily, it appears, by toughening the matrix phase, and inhibiting debonding between matrix and carbide phases. A proposal has been submitted to the Office of Naval Research to continue the study of the effects of implantation on erosion mechanisms of metal/carbide systems.

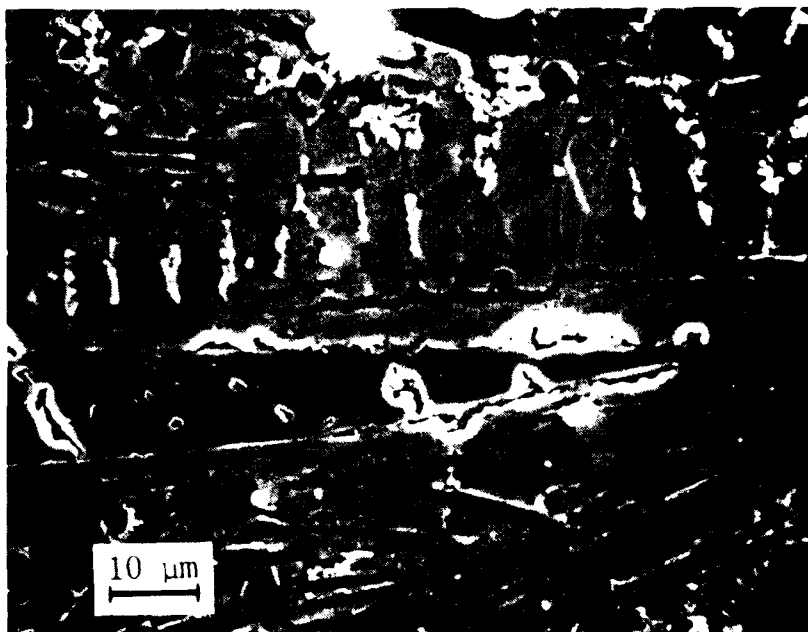
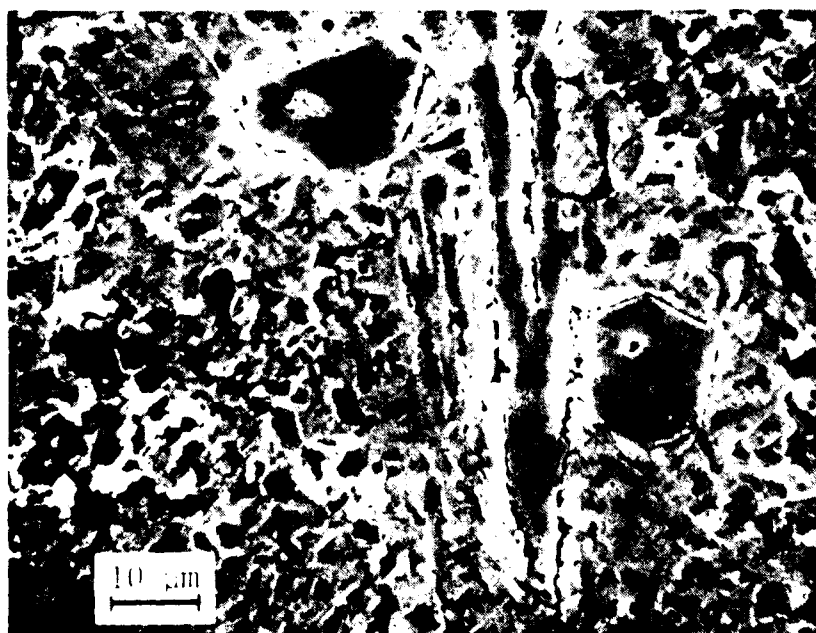
Figure 1. Cavitation erosion tested Stoddy 3 sample after 4 hours of testing (top) and after 6 hours of testing (bottom).

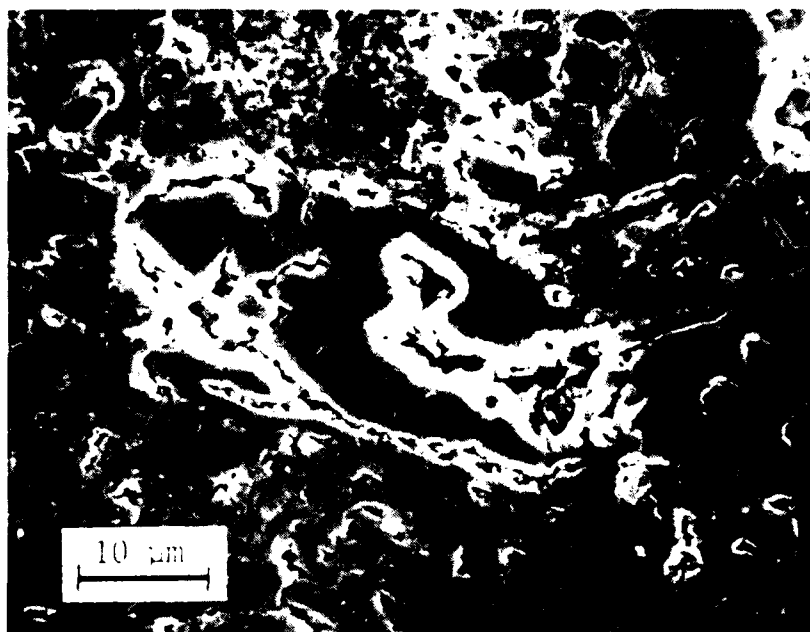
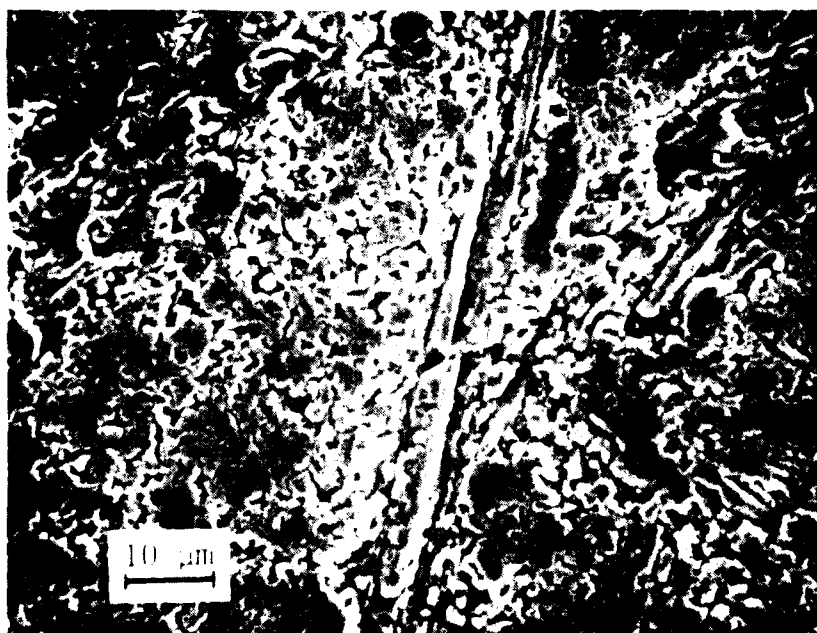
Figure 4. Cavitation erosion tested Stoddy 3 sample after 10 hours of testing (top) and after 25 hours of testing (bottom).

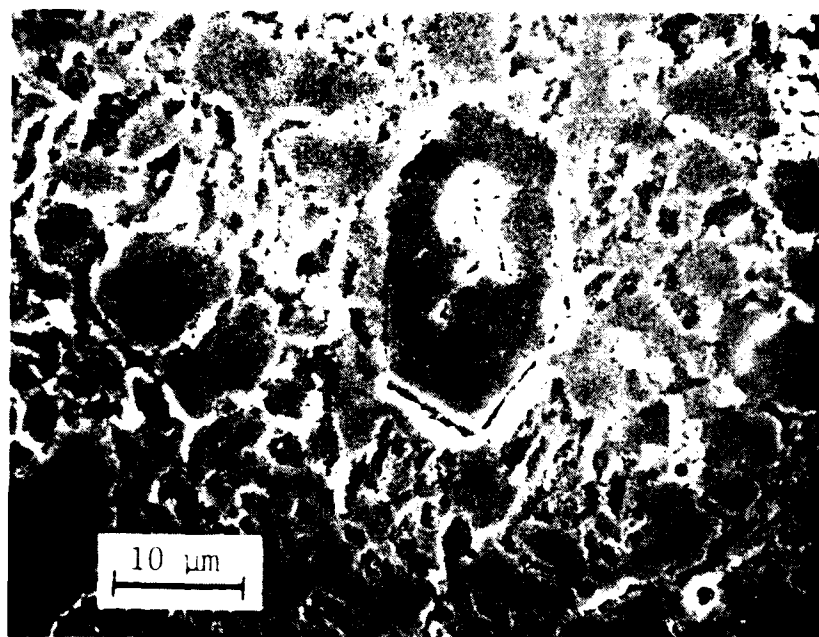
Figure 1. Cavitation erosion tested, implanted tooth 3  
 sample after 1 hour of cavitation and after  
 25 hours of cavitation.

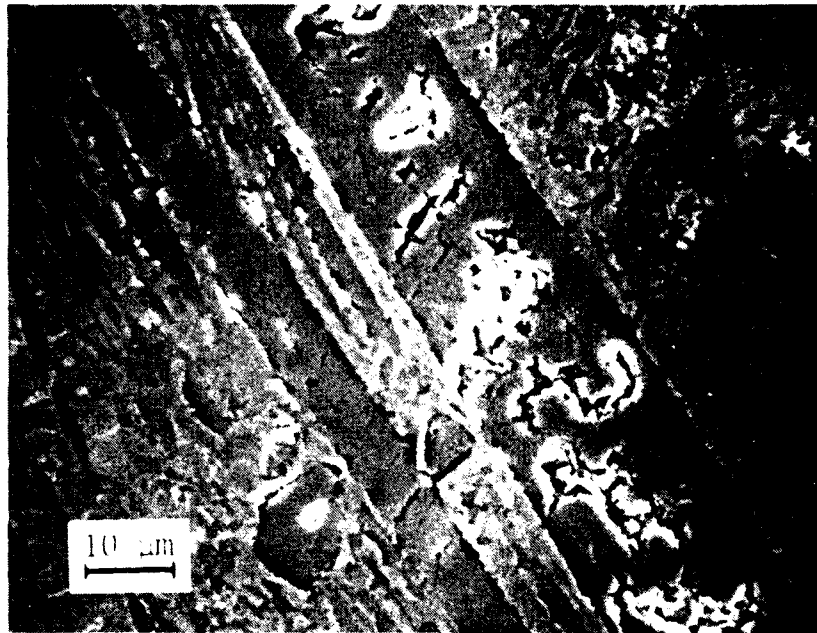
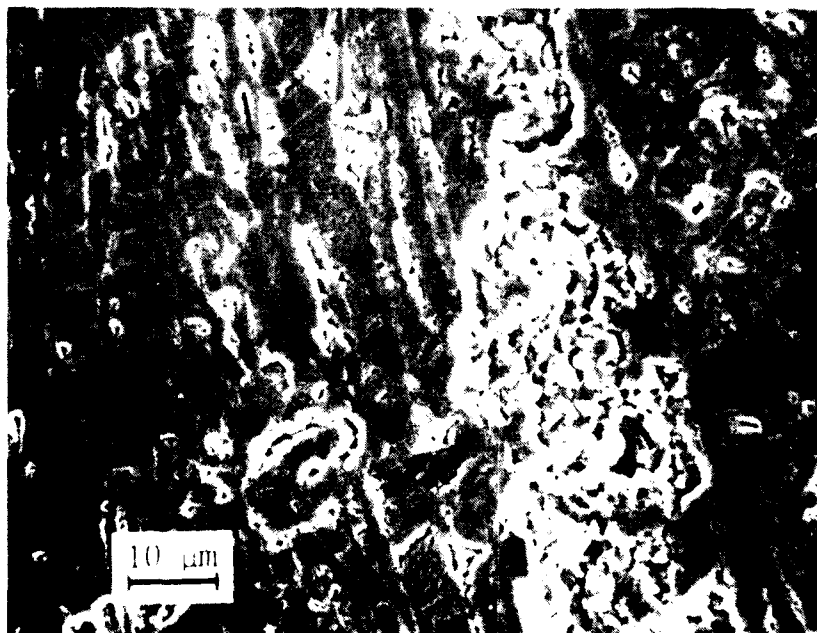
Figure 8. Cavitation erosion tested Ti implanted Stoddy 3 sample after 10 hours of testing (top) and after 20 hours of testing (bottom). Photos show same region as in Figure 7.

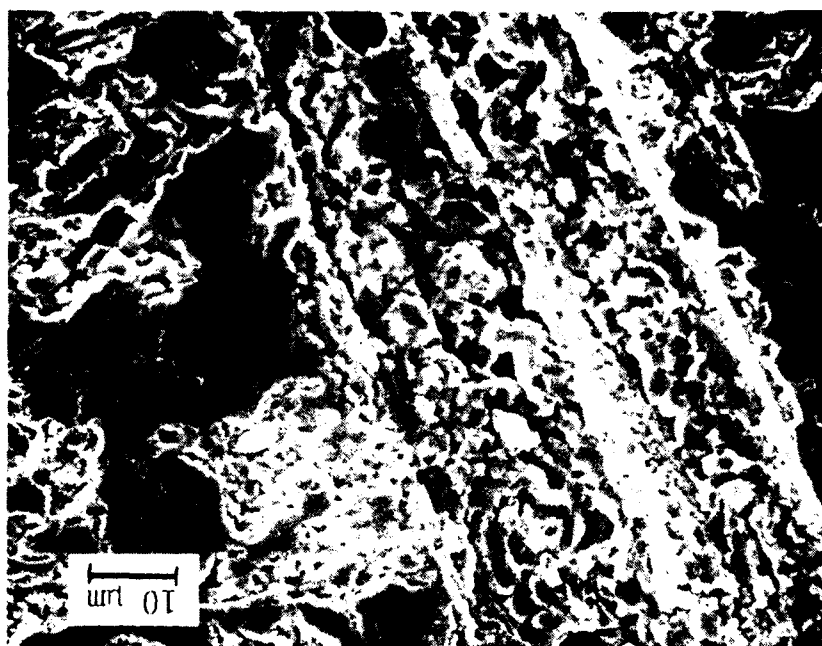
Figure 9. Cavitation erosion tested Ti implanted Stoddy 3 sample after 35 hours of testing. Same region as in Figures 7 & 8.

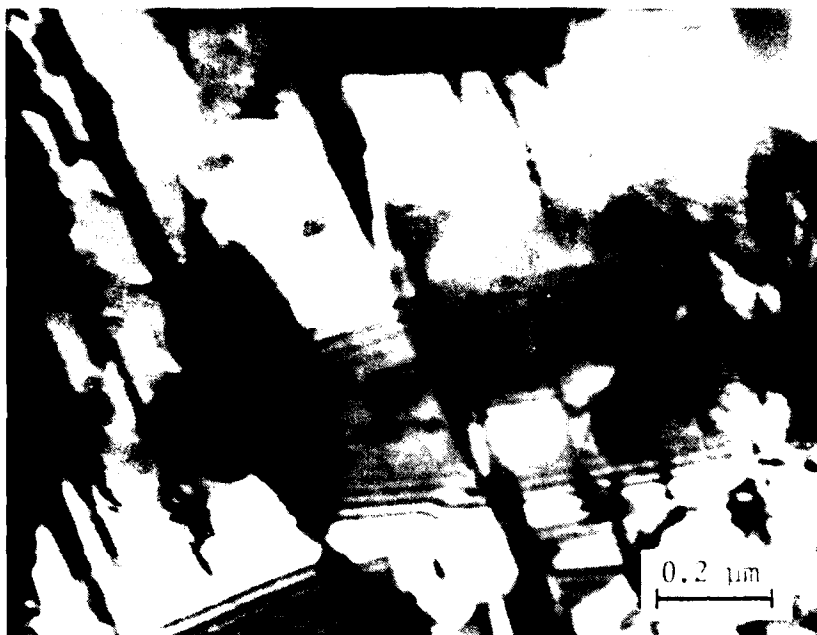
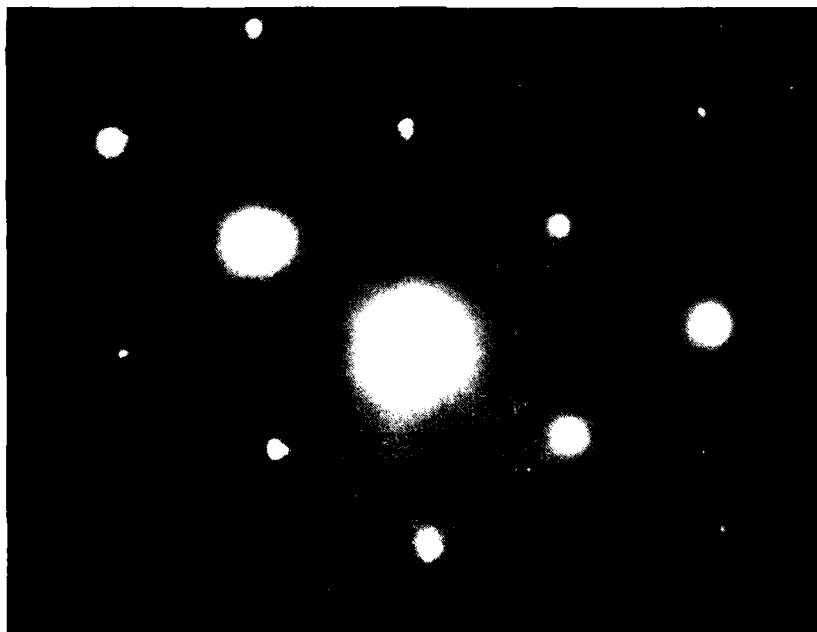
Figure 12. Brightfield micrograph of the matrix phase in a nonimplanted foil and the corresponding SAD pattern (110 zone, fcc).

patterns from the cobalt-rich matrix phase indicated only the presence of the metastable fcc phase (e.g., Fig. 12), suggesting that cold working during the polishing process was not sufficiently severe to produce the martensitic fcc-hcp transformation at the surface. The large carbides appeared semi-opaque and virtually defect free. SAD patterns from these carbides (Fig. 13) were typical of those produced by single crystal complex carbides.

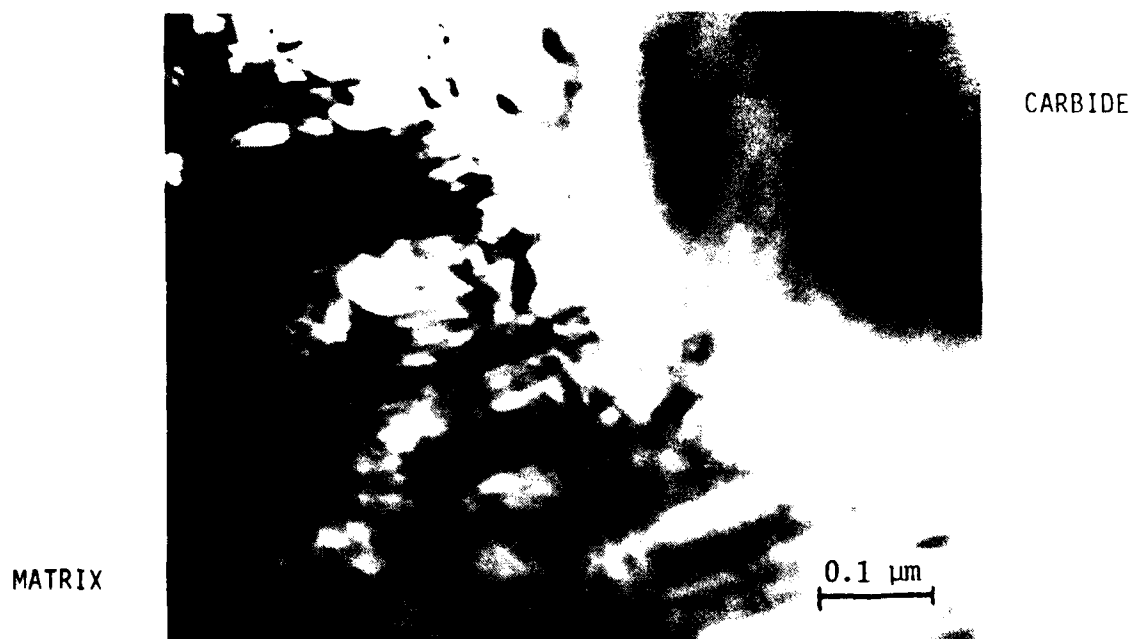
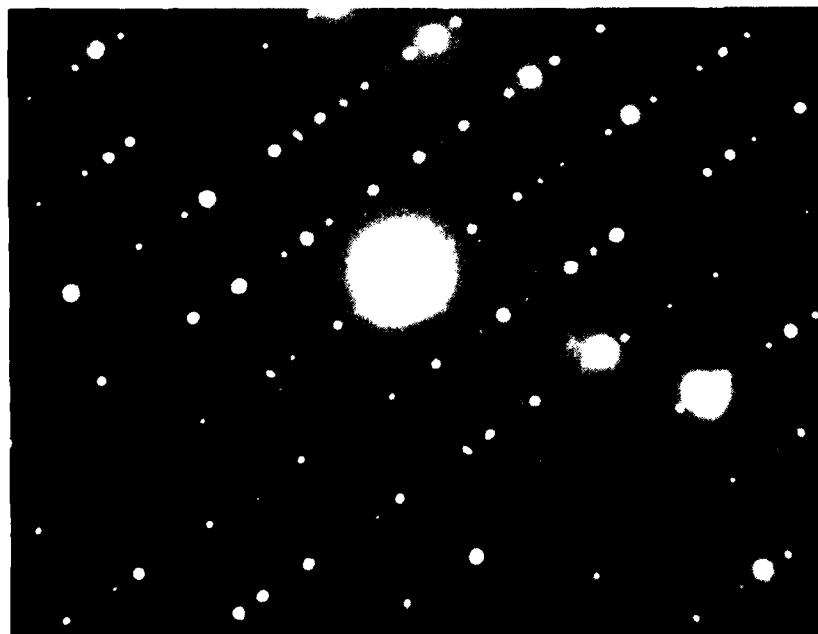
Figure 13. Brightfield micrograph of a carbide-matrix interface with an SAD pattern from the carbide.

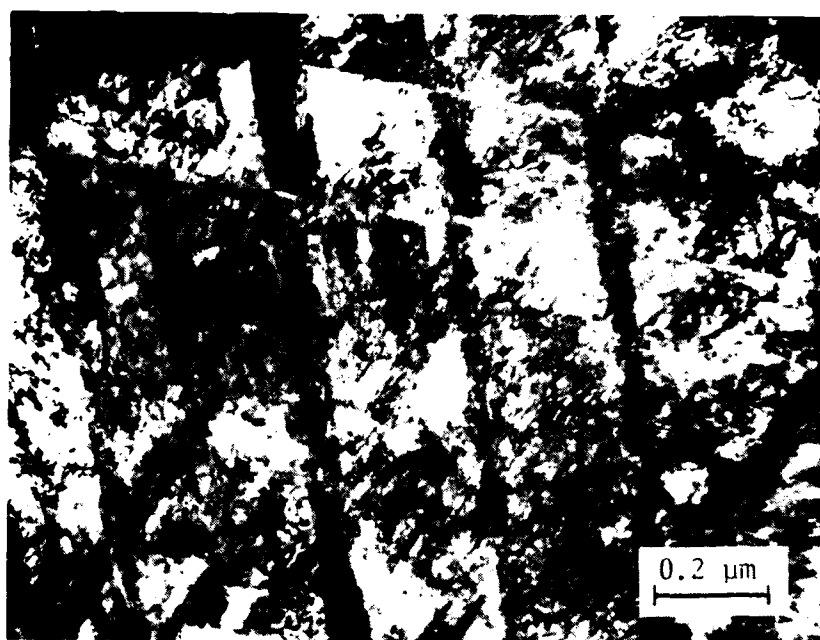
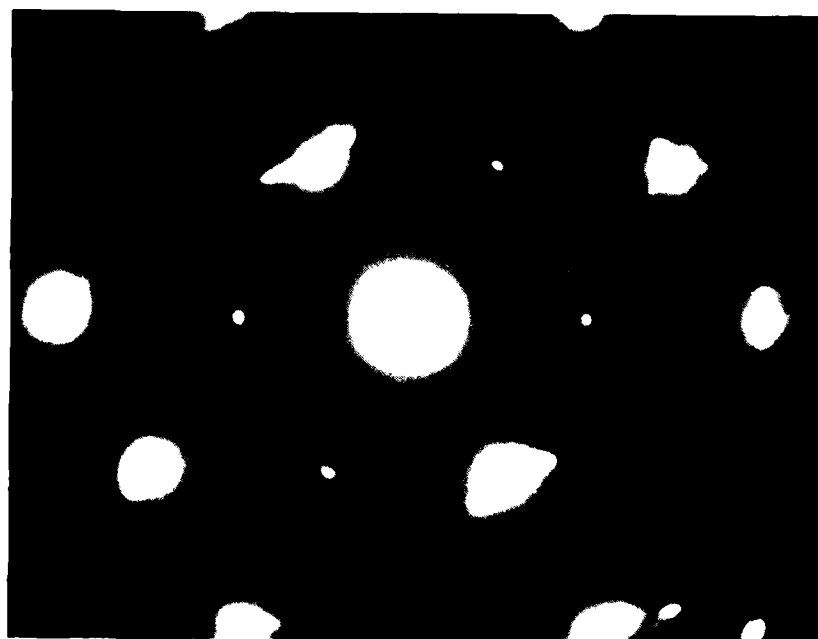
Figure 14. Brightfield micrograph of the matrix phase in an unpolished foil and the corresponding SAD pattern (211 zone, fcc).

In order to investigate the effects of cold work deformation on the alloy microstructure, observations were also made on an unpolished (600 grit SiC paper finish) foil (Fig. 14). A much denser dislocation substructure was observed in this foil than in the fine polished samples (Compare Figs. 12 and 14). Deformation of the sample surface produced streaking and ring segments on the SAD patterns. Again, the cubic phase was predominant in all patterns from the matrix phase (Fig. 14), however the presence of extra spots and streaks superimposed on the basic fcc pattern suggests the possibility that the fcc matrix contained some regions of transformed hcp material.

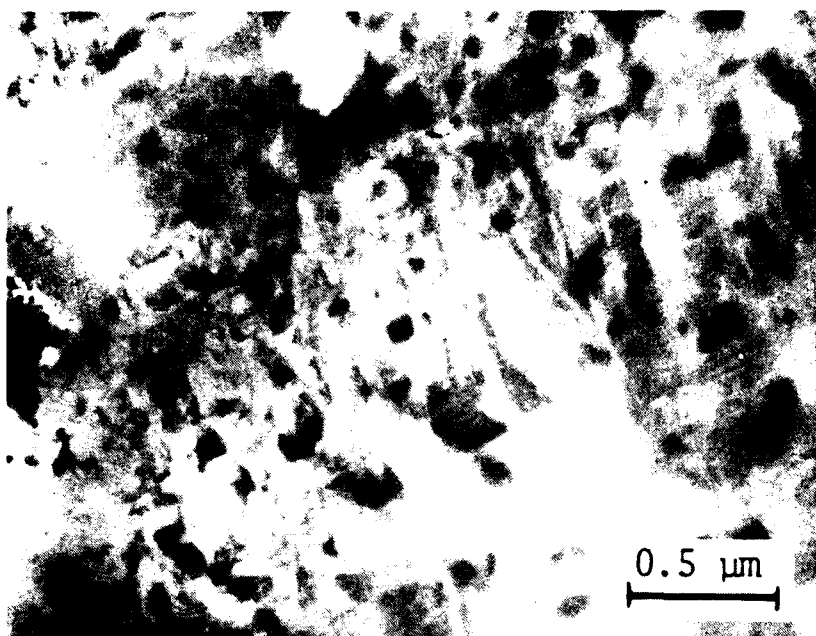
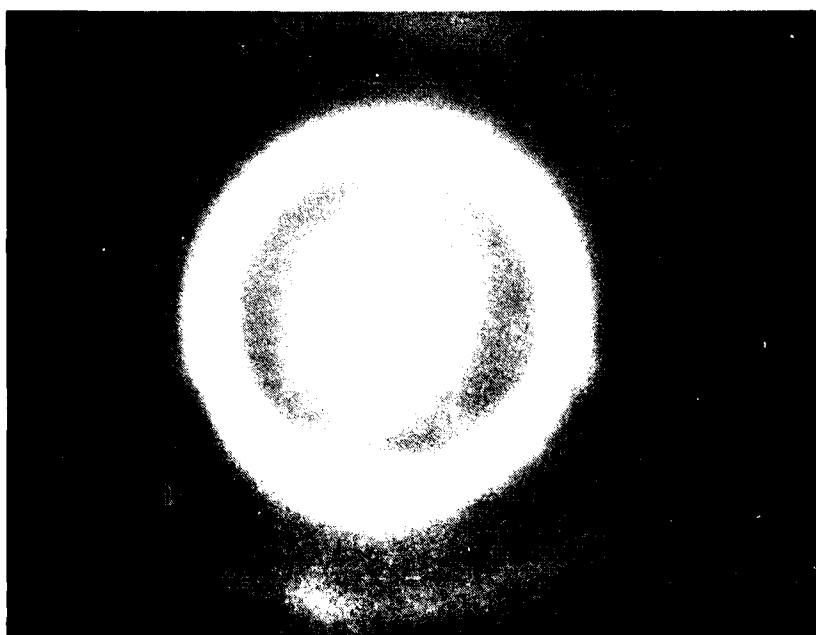
Figure 15. Brightfield micrograph of the matrix phase in a Ti implanted foil and the corresponding SAD pattern. The diffuse rings in the pattern indicated an amorphous surface layer in this phase.

The effects of Ti implantation on the alloy microstructure are shown in Figs. 15-18. Implantation produced an amorphous matrix phase, as evidenced by the diffuse rings in the SAD patterns from this phase, and by the absence of defects i.e., dislocations and planar faults (Fig. 15). Similarly, the carbides were transformed from monolithic single crystals to fine-grained polycrystals (Figs. 16 & 17), with diffraction spots forming ring patterns (Fig. 17). Partial amorphization of the carbide surfaces is suggested by the diffuse nature of the rings. The carbides were outlined by borders of light contrast, matrix material which, on close inspection, appeared carbide depleted. EDX analysis of the border region shown in Fig. 18 indicated higher Ti concentrations in the carbides and bordering matrix than for the neighboring, darker contrast matrix material. Preferential carburization (i.e., the formation of a Ti + C enriched surface layer (7)) at or near the carbides during implantation is a possible explanation of this result.

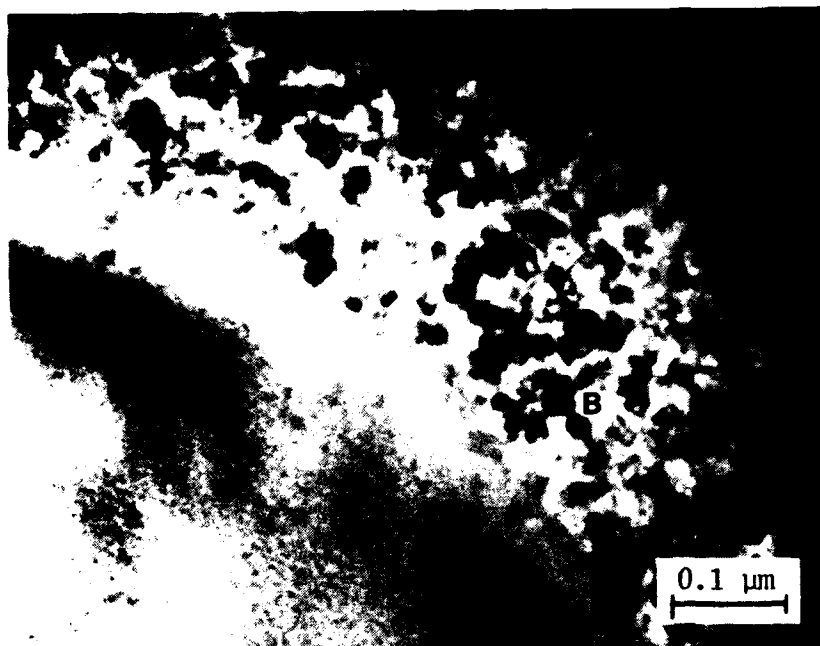
Figure 16. Brightfield micrograph of a) the matrix and b) a polycrystalline carbide in a Ti implanted foil. The EDX spectra identifying the polycrystalline phase as a carbide is also shown.

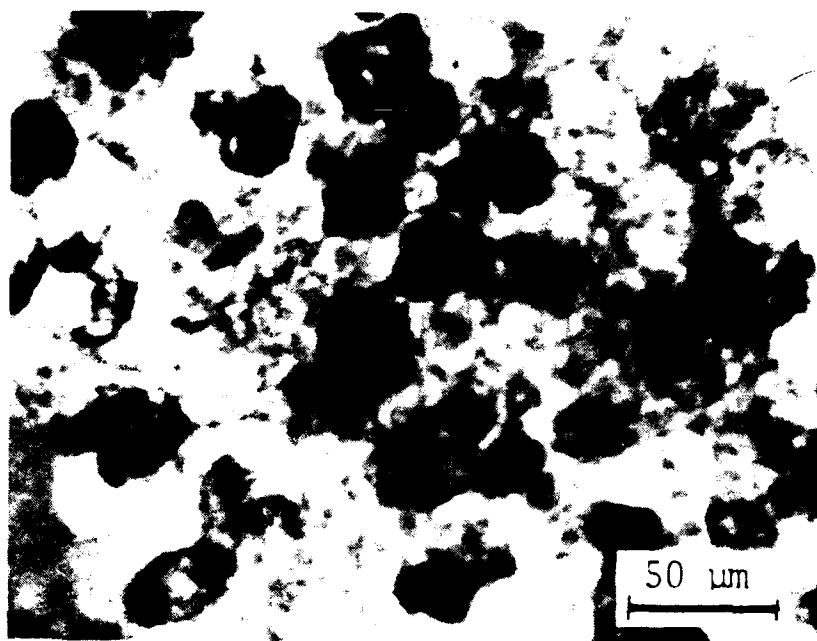
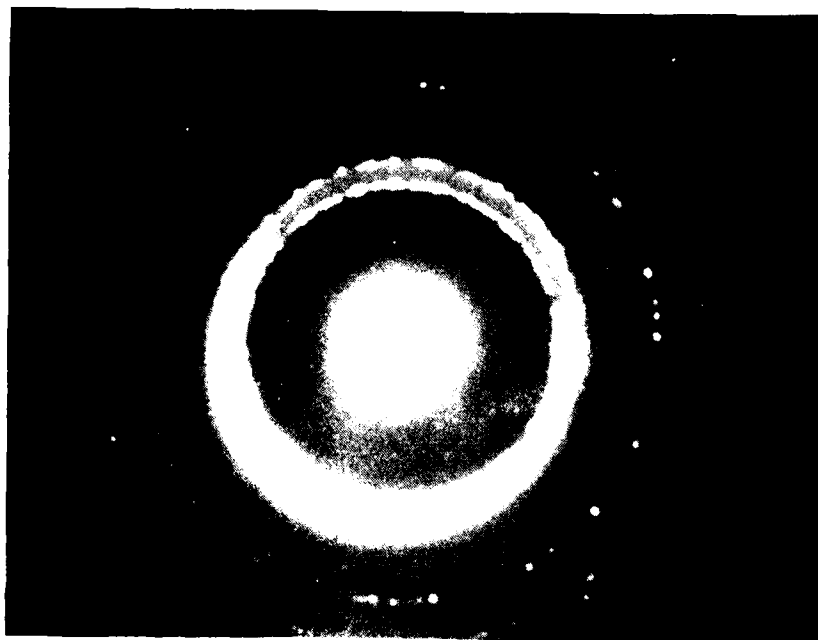
Figure 17. Brightfield micrograph of a carbide in the Ti implanted foil and the corresponding SAD pattern. The rings in the pattern indicated a polycrystalline phase. Partial amorphization of the carbide surface was suggested by the diffuse nature of the rings.

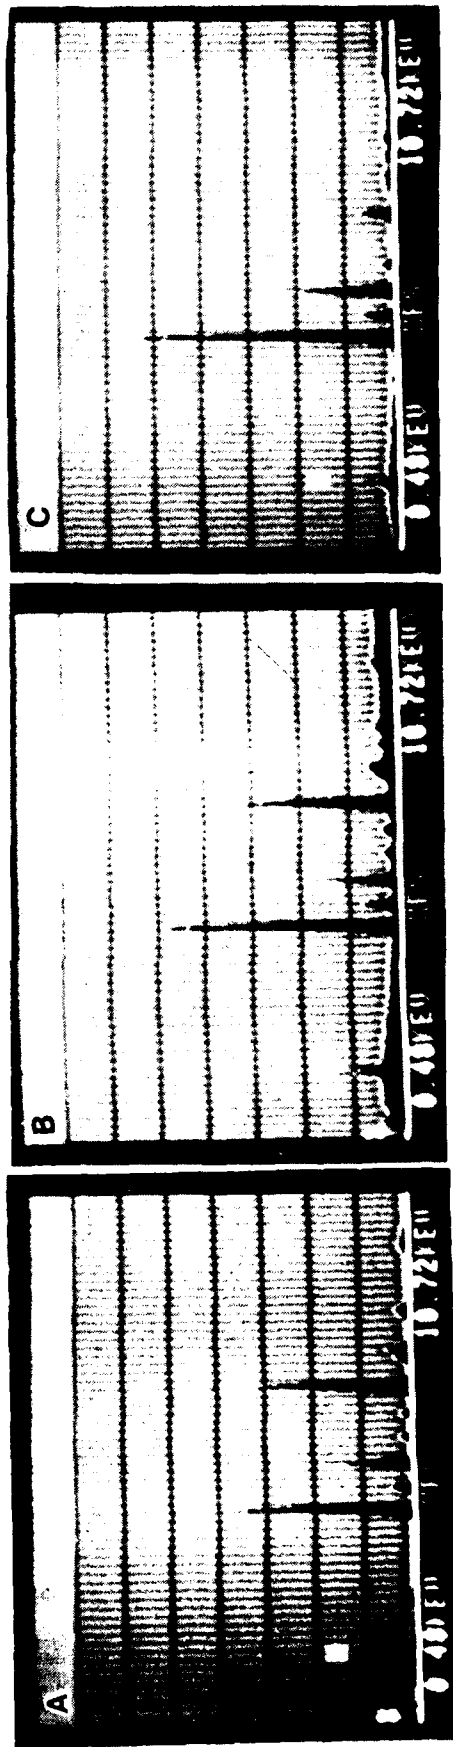
Figure 18. Brightfield micrograph of the Ti implanted foil and EDX spectra from a) matrix, b) matrix material bordering the carbide and c) carbide. The matrix appeared to have a lower surface concentration of Ti than the carbide or bordering matrix material.

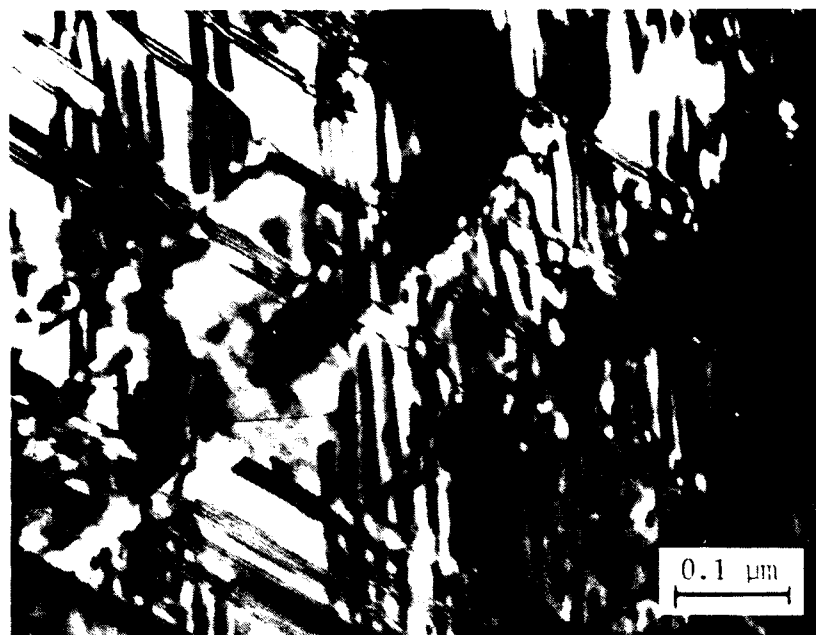
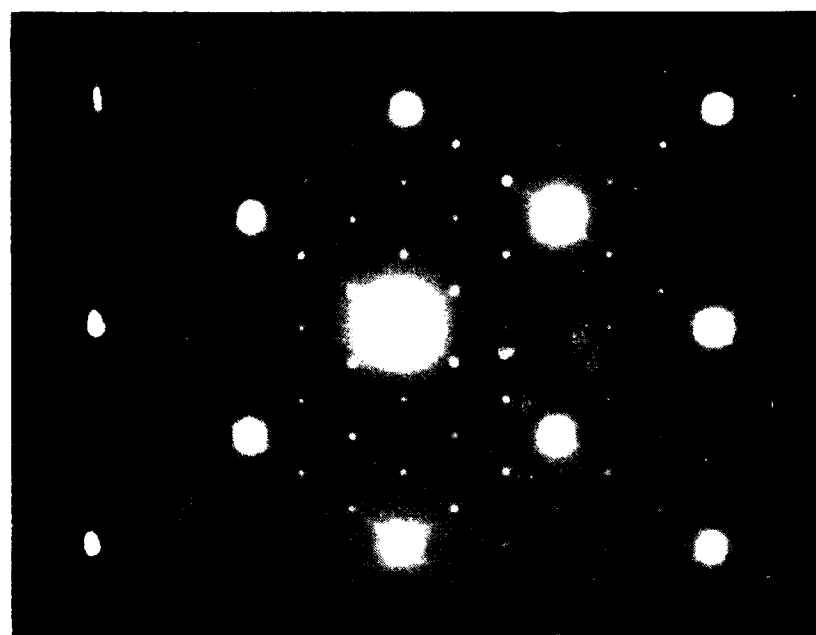
Figure 19. Brightfield micrograph of the matrix phase in a N implanted foil and the corresponding SAD pattern (110 zone, fcc). The extra spots grouped in clusters around the basic fcc cobalt spots are believed to originate from carbides dispersed in the matrix.

Micrographs from a N implanted foil can be seen in Figs. 19 & 20. Single crystal SAD patterns were obtained from both matrix and carbide phases on the foil. As was the case for the nonimplanted foils, the matrix phase was found to be cubic (Fig. 19). Although N implantation did not

produce changes in the crystallinity of the surface, a striking increase in the fault density was observed (Compare Figs. 19 & 20 with Figs. 11 & 12).

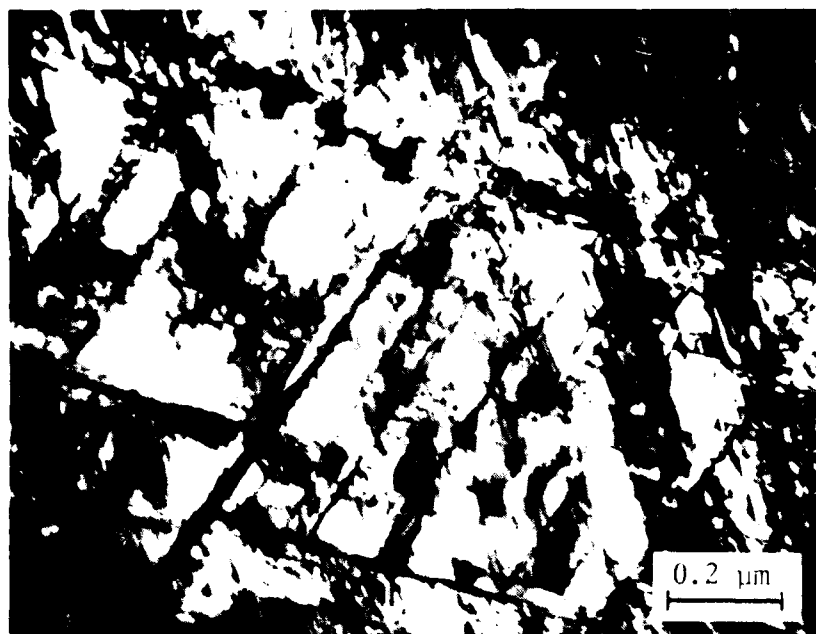
Figure 21. Brightfield micrographs of matrix regions in a W implanted foil. Very high stacking fault densities were seen in this phase.

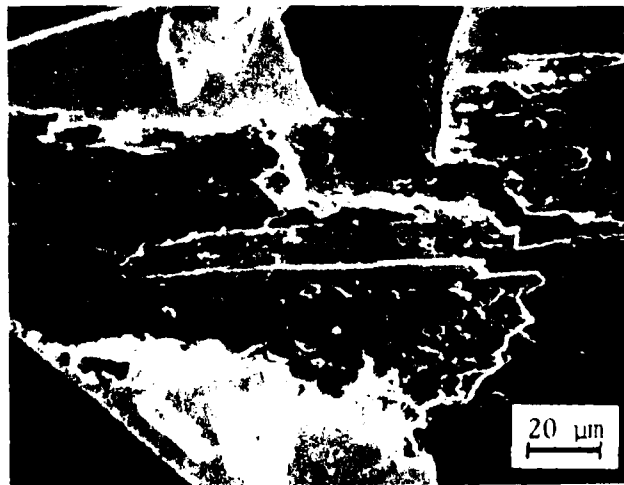
Fig. 1 - Wear track on nonimplanted WC/Ti disk, 80-20, 20 pass region

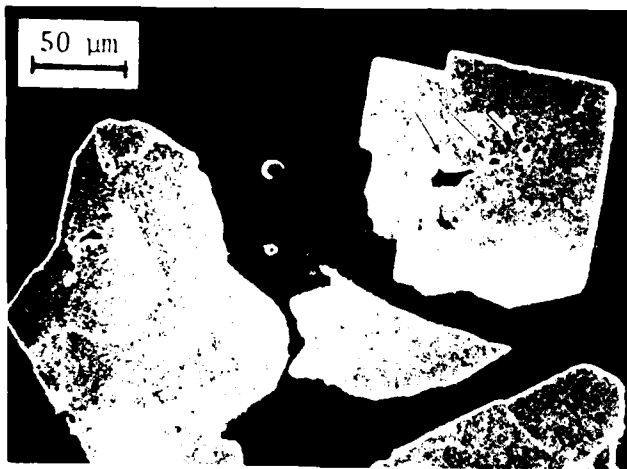
Fig. 2 - Debris on test track #1 on WC/Ti disk 80-20 after Ti implantation, one pass region.

After implantation, all tracks made on the disks were clearly visible. In addition, wear debris containing Fe (from the steel ball) was found in the first pass track on each of the implanted disks (Table III). An illustration of debris on the single pass track of test #1 on WC/Ti disk 80-20 is seen in Fig. 2, which shows large debris fragments attached to carbides. Another example is the 20 pass track on disk

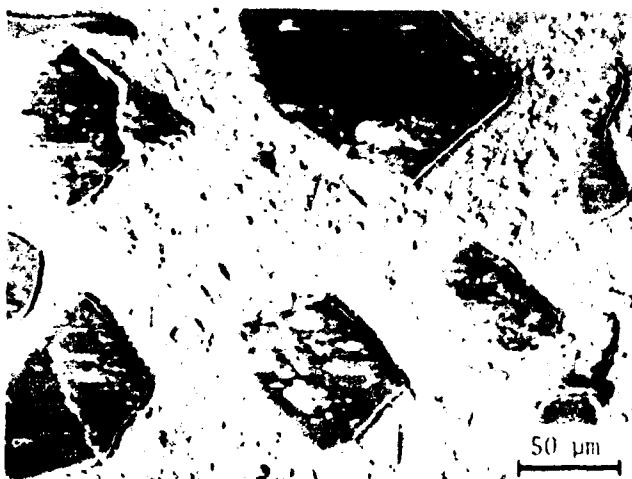
Fig. 4 - 20 pass regions of wear tracks on Ti implanted TiC/Ti disk, 80-5  
Left: SEM micrograph Right: DIC micrograph

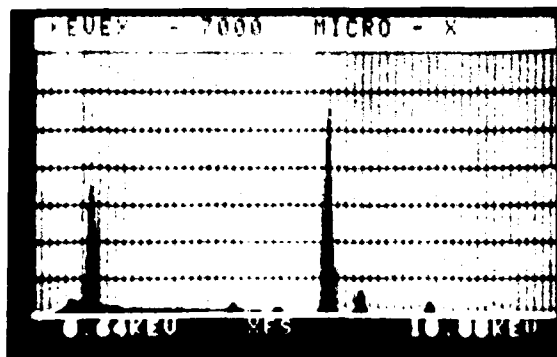
Fig. 5 - Left: Wear scar on steel ball tested against WC/Ti disk Right: EDX signal of a spot on the ball scar

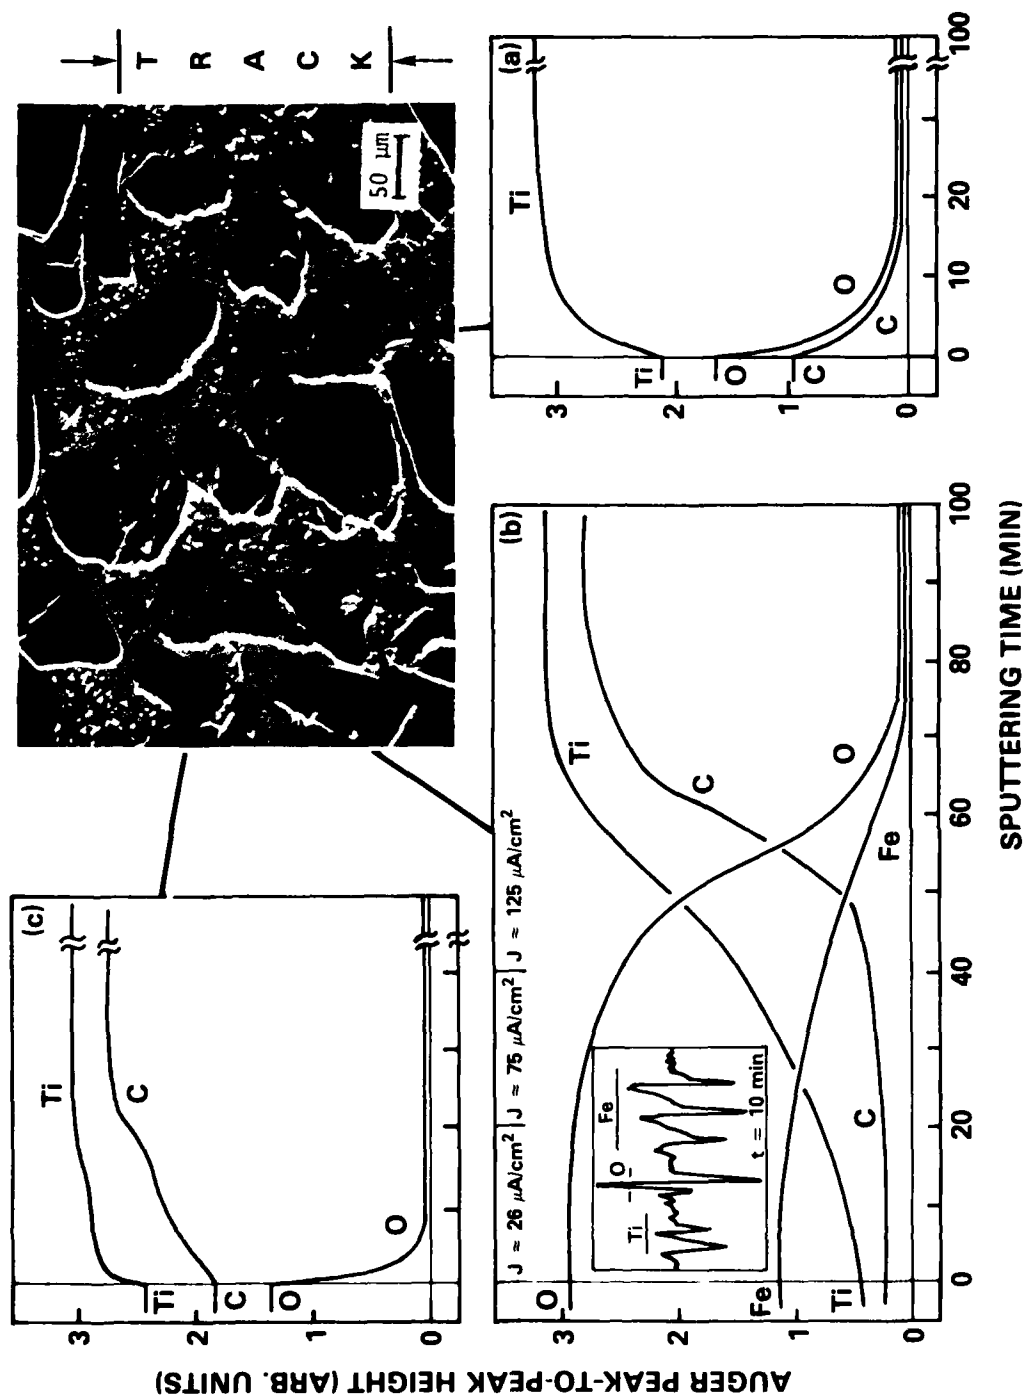
Fig. 6 - Auger sputter depth profiles of a portion of the 20 pass wear track on the Ti implanted TiC/Ti disk, 80-5. Three features of the track shown in the circles in the SEM photo, were profiled concurrently during ion milling: a) non-worn Ti alloy matrix (away from the visible dendritic phase); b) a debris flake attached to a TiC particle; and c) a debris-free carbide surface.
